Corrosion Under Insulation

Corrosion assessment for ArmaGel[™] HT insulation systems tested according to NACE TG516 procedure.

Corrosion assessment for ArmaGel™ HT insulation systems tested according to NACE TG516 procedure.

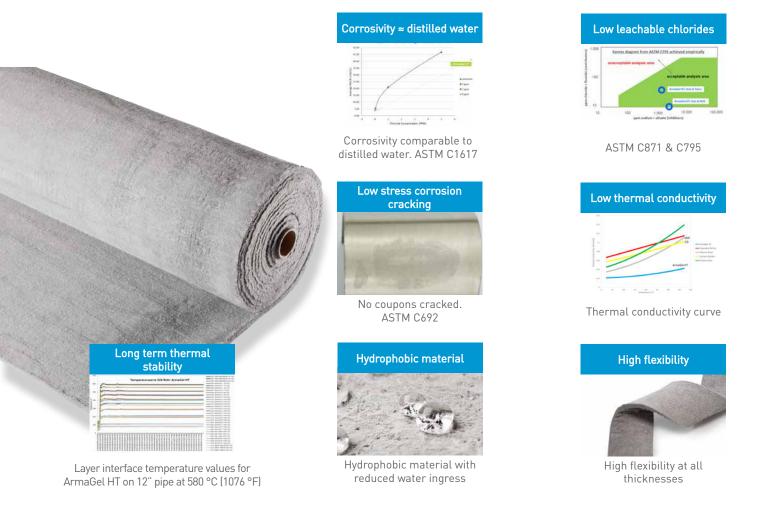
Fig.1: ArmaGel HT - main technical features.

The tested insulation material – ArmaGel HT is a flexible aerogel blanket designed for thermal and acoustic insulation of industrial pipes and equipment. The main features of ArmaGel HT are (see Fig.1):

- Very low thermal conductivity
- High flexibility across thickness range of 5, 10, 15 and 20 mm
- Long-term thermal stability
- Hydrophobic properties
- Low leachable chlorides, meeting criteria of 'Acceptable Analysis' in ASTM C795
- Low stress corrosion cracking (no coupons cracked) acc. to ASTM C692 for austenitic stainless steels
- Low Mass Loss Corrosion Rate (MLCR) which is comparable to distilled water acc. to ASTM C1617 for unprotected carbon steel

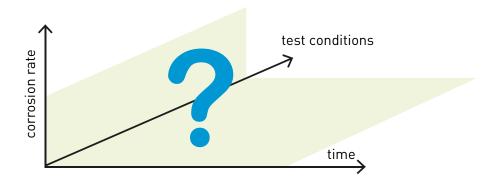
Fig.2: Purpose of TG516 test – corrosion rate in defined conditions and test time.

- Long term corrosion behaviour to be predicted
- Decisions regarding pipework/equipment design and coating to be made
- Select insulation material and system appropriate for particular project based on facts according to test results (see Fig. 2).

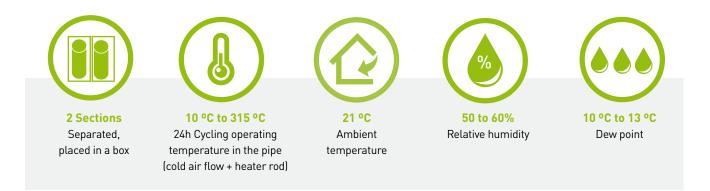
Fig.4: Conditions of high temperature cycle test.

- » High temperature cycle test cycling above or below the dew point intermittently (in 24h period), see Fig. 4
 - (No specific temperature values are given in the standard.)

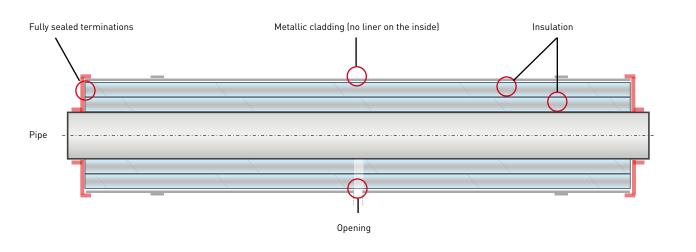
Fig.5: Set of the tested pipe and applied insulation system according to TG516.

- Pipe: NPS 2 inch (50.8 mm inner diameter, 3.9 mm pipe wall thickness), length 12 inch (305 mm), carbon steel uncoated. Altogether four pipes were prepared: two for each temperature test scenario

- Insulation: 2 x 10 mm ArmaGel HT aerogel blanket fixed with wire
- Cladding: 316 stainless steel (austenitic) with 0.017 inch (0.34 mm) thickness. Unsealed overlap of 2 inch (50 mm). Secured with banding

- Insulation and cladding sealed tightly at terminations to eliminate water ingress there
- Opening: Ø6 mm opening in the cladding at 6 o'clock position for initial 40 days of the test, the opening was extended into insulation up to the pipe surface after 40 days

- The vessels in which the tested pipes were placed were filled with tap water for 9 hours each day from Monday to Friday and kept drained for 15 hours (in 24h cycles). For Saturday and Sunday, the vessels were left completely drained. After 30 days of test duration the tap water was replaced with 1500 ppm chloride solution.
- Three electrochemical measurements used to determine the corrosion rate during the test were applied:
 - » EIS = Electrochemical Impedance Spectroscopy
 - » OCP = Open Circuit Potential
 - » SCE = Saturated Calomel Electrode
- After the 6 months = 188 days corrosion rate was measured with UT = Ultrasonic Thickness technique
- Separately also the depth of pitting corrosion was measured
- Finally, the condition of insulation blankets was also evaluated
- For construction details of the tested pipe and insulation see Fig. 5.

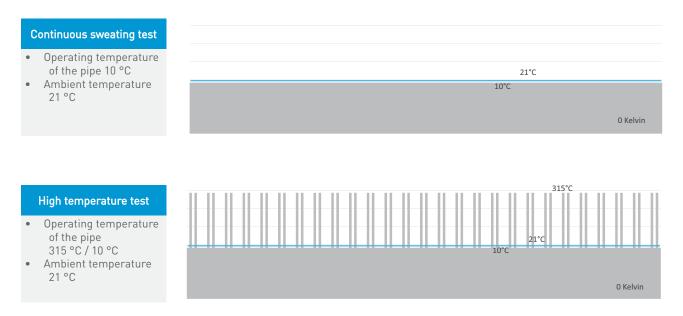
For the continuous sweating test, the corrosion process was notably slow throughout the entire test period. For the high temperature cycle test, high corrosion rates were observed during the filling and the early part of the draining period, even though this accounted for not more than 20% of the whole test duration. Moreover, the high corrosion rates which took place within this relatively short time period in the cycle (< 20%) resulted in notably higher overall corrosion than in the case of continuous sweating test with a slow but continuous corrosion process. The key factor for high corrosion rate clearly relates to the cyclic operating temperatures between the relatively low temperature of 10 °C (50 °F) (below the dew point) and very high temperature of 315 °C (600 °F).

For the continuous sweating (condensation) test at operating temperature of 10 °C (50 °F) and ambient temperature of 21 °C (70°F) the following corrosion behaviour patterns were present in each week (see Table 1 and Fig. 6.1):

On the other hand, for the high temperature cycle test at operating temperature of 315 °C/10 °C (600 °F/50 °F) and ambient temperature of 21 °C (70 °F) the following corrosion behaviour patterns were present in each week (see Table 2 and Fig. 6.2):

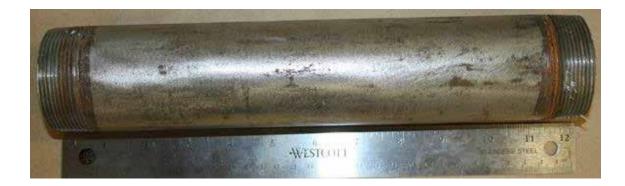
Fig.7.1: Pipe surface of continuous sweating test after the test with traces of corrosion (after cleaning).

Regarding the pipe surface, isolated red and black corrosion deposits were found on the surface. There was superficial uniform corrosion on the surface in "strings" (or lines) directly under the insulation creases. The corrosion resulted led to an average measured loss of pipe wall thickness of 15.2 μ m (after full 6 months). When converted to an annual value, the uniform corrosion rate was determined to be between 20 to 40 μ m/year (see Fig. 7.1).

A small amount of pitting corrosion was observed at the end of the test with a few pits found with their depth up to max. 150 µm (i.e. 4% of the pipe thickness).

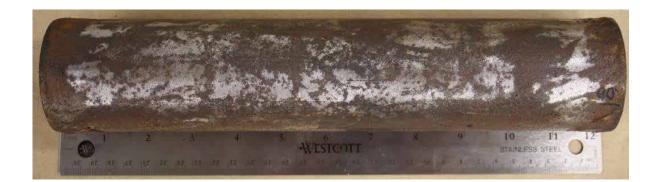
Fig.7.2: Pipe surface of high temperature cycle test after the test with traces of corrosion (after cleaning).

Regarding the pipe surface, red and black corrosion deposits were found over most of the surface. These deposits were deemed likely to be of oxide and magnetite oxide. According to the report of SwRI the presence of magnetite oxide film on the pipe surface is expected to help to impede corrosion rate and protect metal from further corrosion.

Overall, uniform corrosion was more pronounced than for the pipes tested under the continuous sweating condition. The average loss of pipe wall thickness was 22.9 μ m (after 6 months). Converted to annual values, the uniform corrosion rate was determined to be from 32 to 54 μ m/year (see Fig. 7.2).

Some pitting was also observed, with their depth reaching up to max. 180 µm (i.e. 5% of pipe wall thickness).

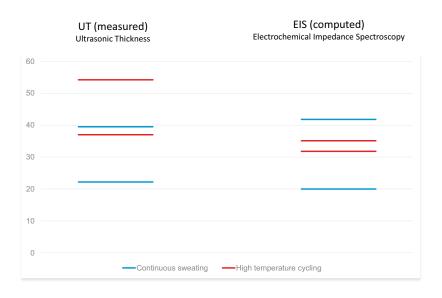
Figure 8 shows the corrosion rates measured for the continuous sweating (condensation) test and high temperature cycle test with ultrasonic thickness measurement after the test and with EIS method during the test.

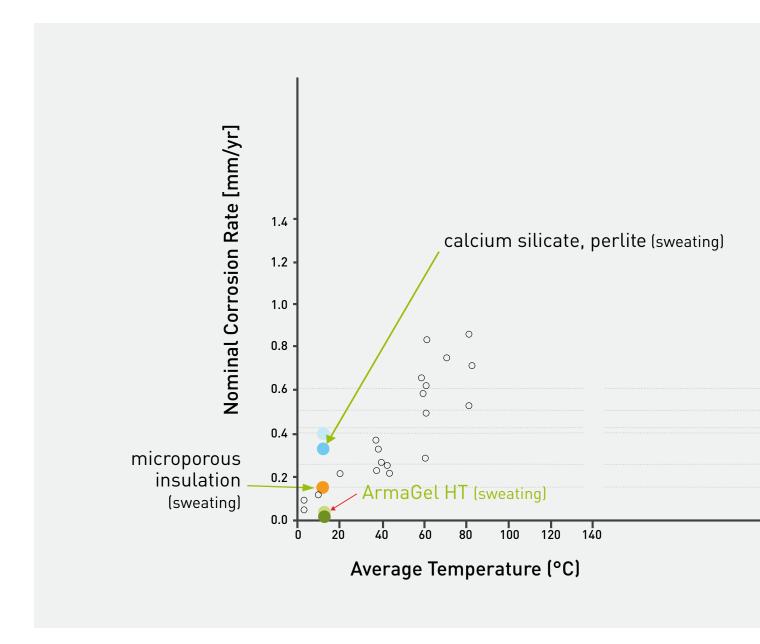
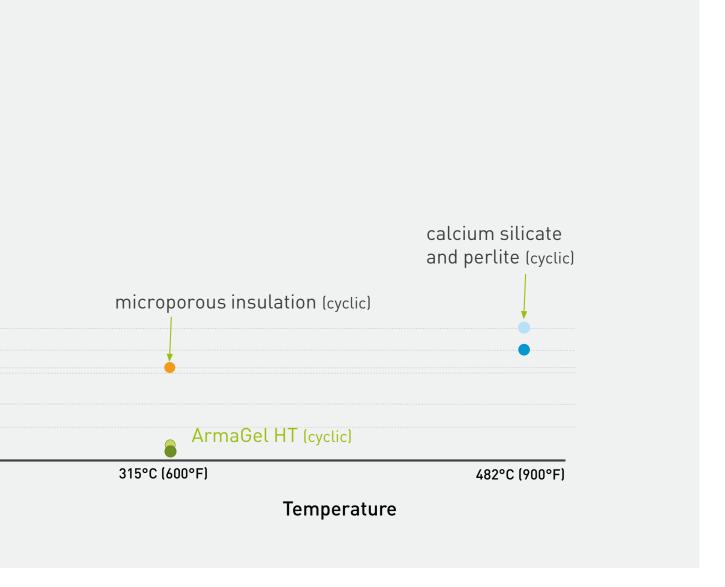
Figure 9 shows test results of ArmaGel HT according to NACE TG516 and comparable test results for other insulation materials. For many of the other insulation materials the corrosion rate is much higher.

When comparing available published test results, the corrosion rates of unprotected carbon steel under ArmaGel HT in wet conditions are observed to be significantly lower than the corrosion rates under other insulation materials, specifically:

- microporous insulation
- calcium silicate
- perlite
